DEVELOPMENT OF THE
LOCKHEED SR-71 BLACKBIRD

Clarence L. Johnson
Senior Advisor
Lockheed Corporation

J58/SR-71 PROPULSION INTEGRATION
OR
THE GREAT ADVENTURE INTO THE TECHNICAL UNKNOWN

By William H. Brown, Retired Engineering Manager
Government Product Division
Pratt & Whitney Aircraft Group
United Technologies Corporation

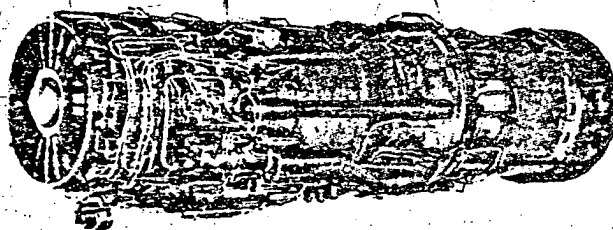
J-58 (JT11-D20)

The centerline of the basic J58 engine was laid down in late 1956. It was to be an afterburning turbojet rated at 26,000 lb maximum takeoff thrust and was to power a Navy attack aircraft which would have a dash capability of up to Mach 3 for several seconds. By the time Pratt & Whitney Aircraft, along with Lockheed and others, began to study the SR-71 "Blackbird" requirements several years later, we had completed approximately 700 hours of full-scale engine testing on the J58.

Figures 1 and 2 indicate some of the increased requirements of the "Blackbird" engine compared to the requirements for the previous J75 engine. As it turned out, even these requirements didn't hold throughout the "Blackbird's" actual mission. For example, the engine inlet air temperature exceeded 800°F under certain conditions. The fuel inlet temperature increased to 350°F at times and the fuel temperature ranged from 600°F to 700°F at the main and afterburner fuel nozzles. Lubricant temperatures rose to 700°F and even to 1000°F in some localized parts of the engine.

Because of these extremely hostile environmental conditions, the only design parameters that could be retained from the Navy J58-P2 engine were the basic size and the compressor and turbine aerodynamics. Even these were modified at a later date.

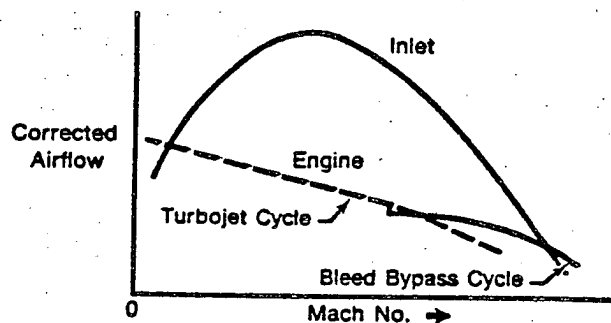
Figure 3. Inlet and Engine Air Flow Match.

Early in the development, we found that a straight turbojet cycle did not provide a good match for the inlet nor the required net thrust at high Mach number operating conditions. To overcome these problems, we invented the bleed by-pass cycle with which we could match the inlet airflow requirements as shown in Figure 3. Another advantage of this cycle was that above Mach 2, the corrected airflow could be held constant at a given Mach number regardless of the throttle position. The bleed by-pass cycle also provided more than 20 percent additional thrust during high Mach number operation. See Figure 4.

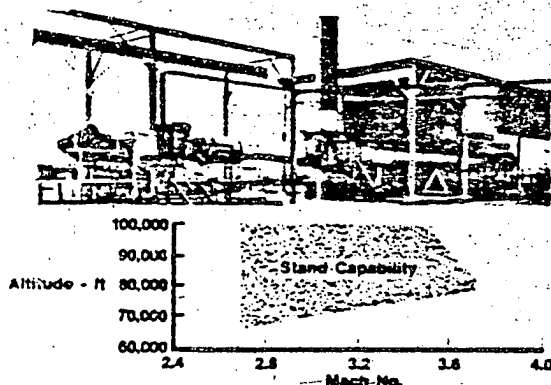
Figure 5. Heated Environment Test Stand

If the foregoing were not enough, developmental testing problems also had to be overcome. There were no test facilities which had the capabilities to provide steady-state temperature and pressure conditions required for testing at maximum operating conditions nor could they provide for performing transients. A partial solution is shown in Figure 5. On this test stand, the exhaust of a J75 engine was run through and around the J58 to simulate transients of the temperature environment.

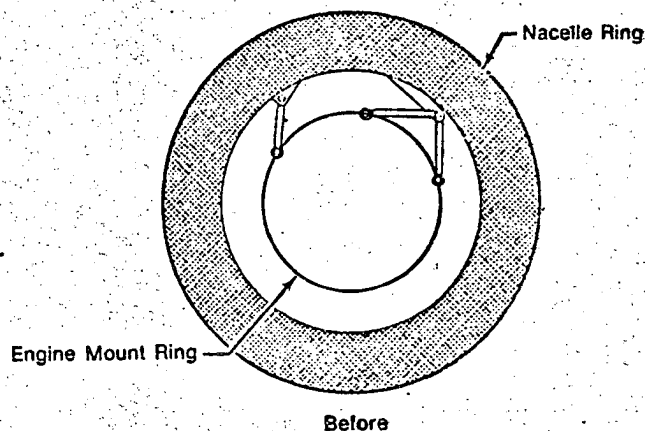
Figure 7. Engine Mount

Originally, the engine was mounted on a stiff rail structure at the top of the nacelle with a stabilizing link from the top of the engine rear mount ring to the aircraft structure as shown in Figure 7. To solve the crushing problem Pratt & Whitney Aircraft redesigned the rear mount ring so that a tangential link could be installed between the engine and the outboard side of the nacelle. This maintained a finite distance between the nacelle and engine under all conditions. See Figure 8.

A mounting-related problem occurred under certain conditions of down load on the wing. At these conditions, the outer half of the nacelle would rotate into the engine and crush the engine plumbing and anything else in the way.

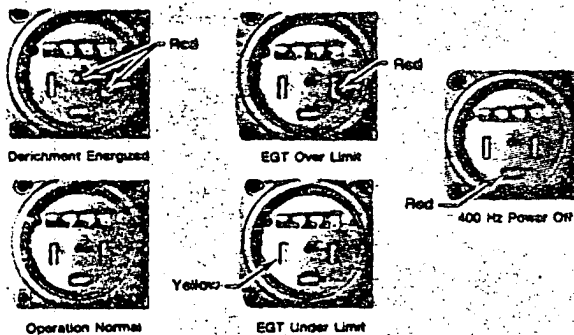
Figure 9. EGT Vernier Control System - EGT Error Gage Operating Modes

unexpectedly sharp atmospheric changes were encountered. These, in combination with the speed of the aircraft, resulted in changes too fast for the pilot to handle. By the time he read the engine inlet temperature and adjusted the EGT, the inlet temperature had changed. This caused some inlet unstarts (highly reduced inlet airflow) and other undesirable results. To correct this unacceptable state of affairs, Pratt & Whitney Aircraft proposed to revise the aircraft EGT gauge by feeding in an engine inlet temperature signal and adding some additional gadgetry to trim automatically. The digital EGT readout was retained as was an override manual trim in case of failure. See Figure 9. This modification has worked well ever since.

As mentioned previously, there was a minimum of electronics in the engine control system because electronics would not survive the environment and the fuel was already too hot to provide cooling. Consequently, control adjustments normally made automatically had to be made manually. For example, the pilot operated a vernier trimmer to make fine adjustments in the EGT (Exhaust Gas Temperature) as conditions varied from standard (one such device was used successfully in the U-2). The pilot was provided with a curve of EGT versus engine inlet temperature to make the required manual adjustments. However,
